# **Navajo Abandoned Uranium Mine**

## **Site Screen Report**

### **NA-0509A AUM Site**

**Weston Solutions, Inc.**

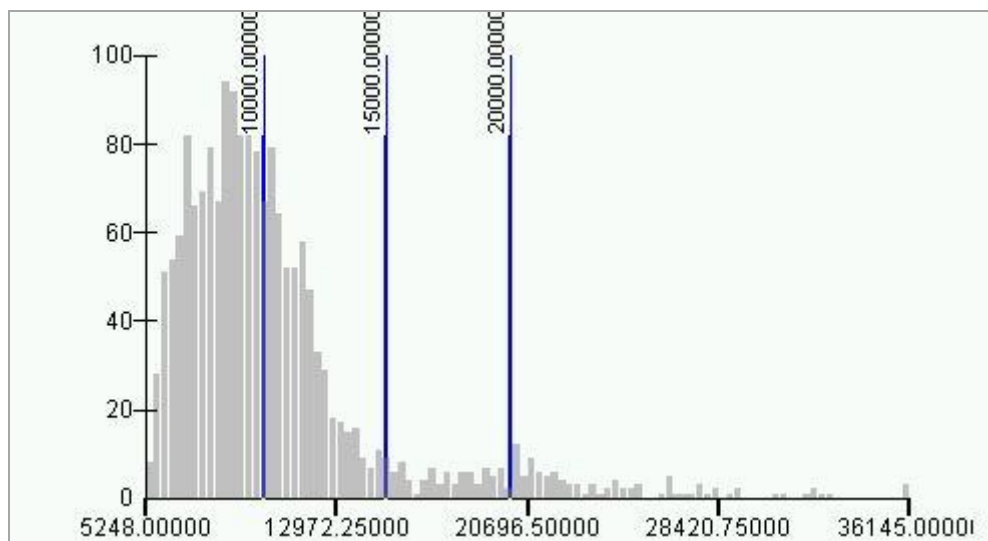
The following chart and statistics were generated by ESRI ArcGIS 9.3.1, and show the general distribution of the site gamma radiation measurements. The horizontal X axis represents the gamma radiation reading levels in cpm (lowest levels to the left). The vertical Y axis represents the frequency of each gamma radiation level.

Count:	1772
Minimum:	5248.00000
Maximum:	36145.00000
Sum:	18541526.00000
Mean:	10463.61512
Median:	9398.50000
Standard Deviation:	4336.37360

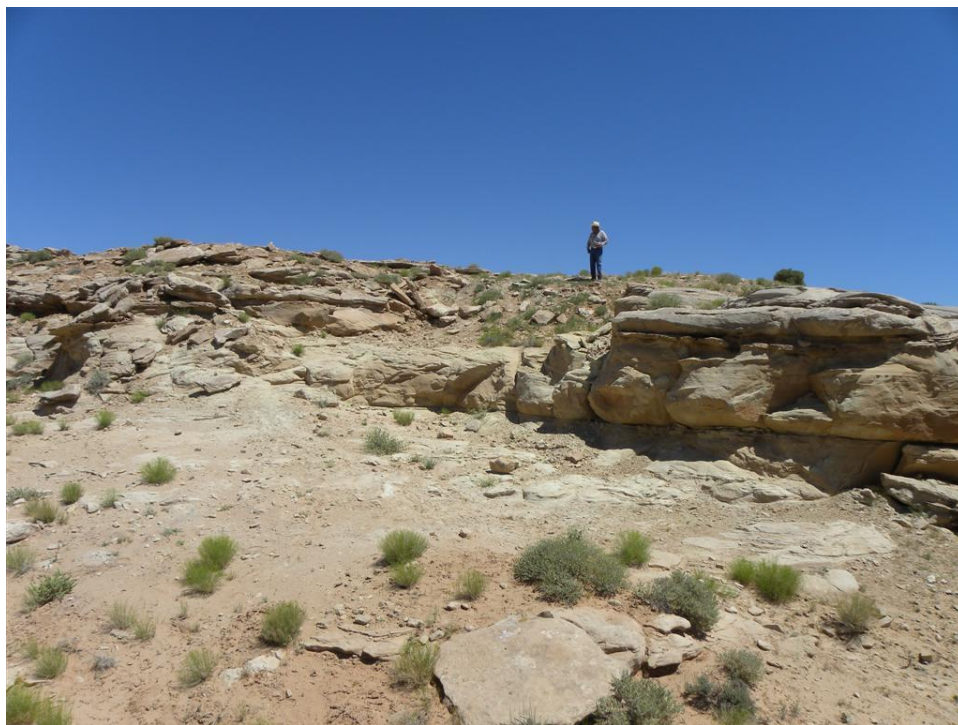
According to Navajo AML (Carl Holiday), a former waste pile was covered, immediately E of site boundary, 30' x 30' area

Photo 1. NA-0509A site, former waste pile area

Covered waste pile, immediately E of site boundary, 30' x 30'

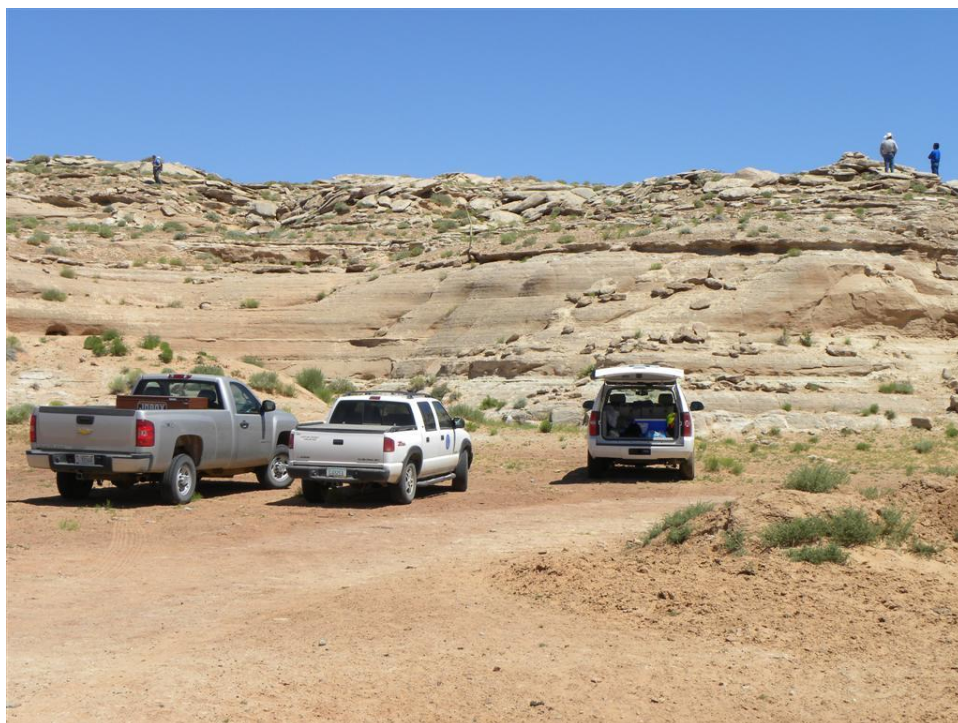
**0 to 0.25 miles:** Windmill well immediately S of site boundary

Photo 2. NA-0509A site, taken from base of windmill well

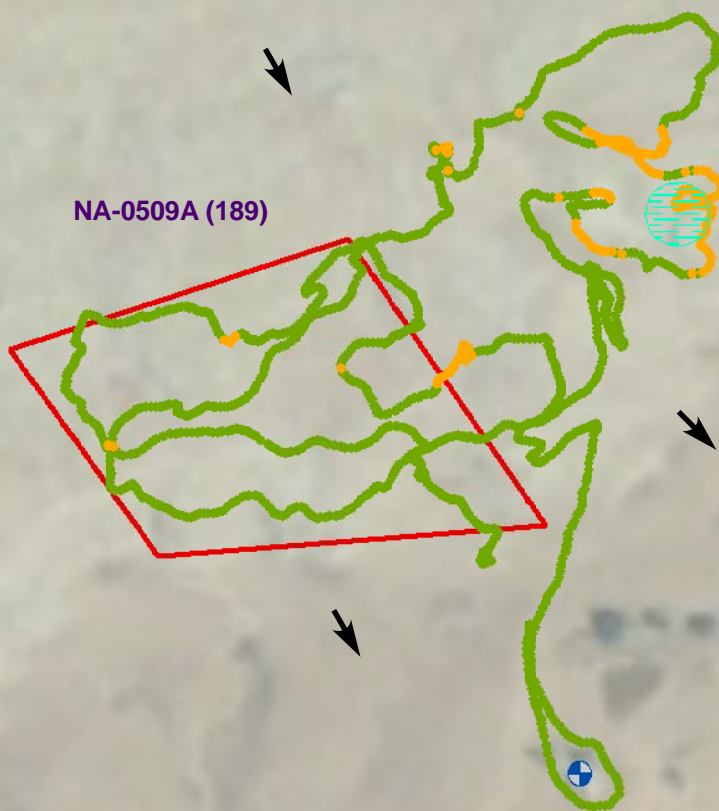
**Figure 1 - Gamma Radiation Measurements, Above Two Times Background  
NA-0509A (189)  
Red Mesa Chapter, Navajo Nation**

A total of 1,772 gamma radiation measurements were collected from the mine site, ranging from 5,248 cpm to 36,145 cpm. Measurements collected in the vicinity of the covered former waste pile area were found at levels up to approximately 30,000 cpm. The measurements are represented in Figures 1 and 2.

Gamma survey conducted 06/2010  
Measured as counts per minute (cpm)

Average background = 6,955 cpm

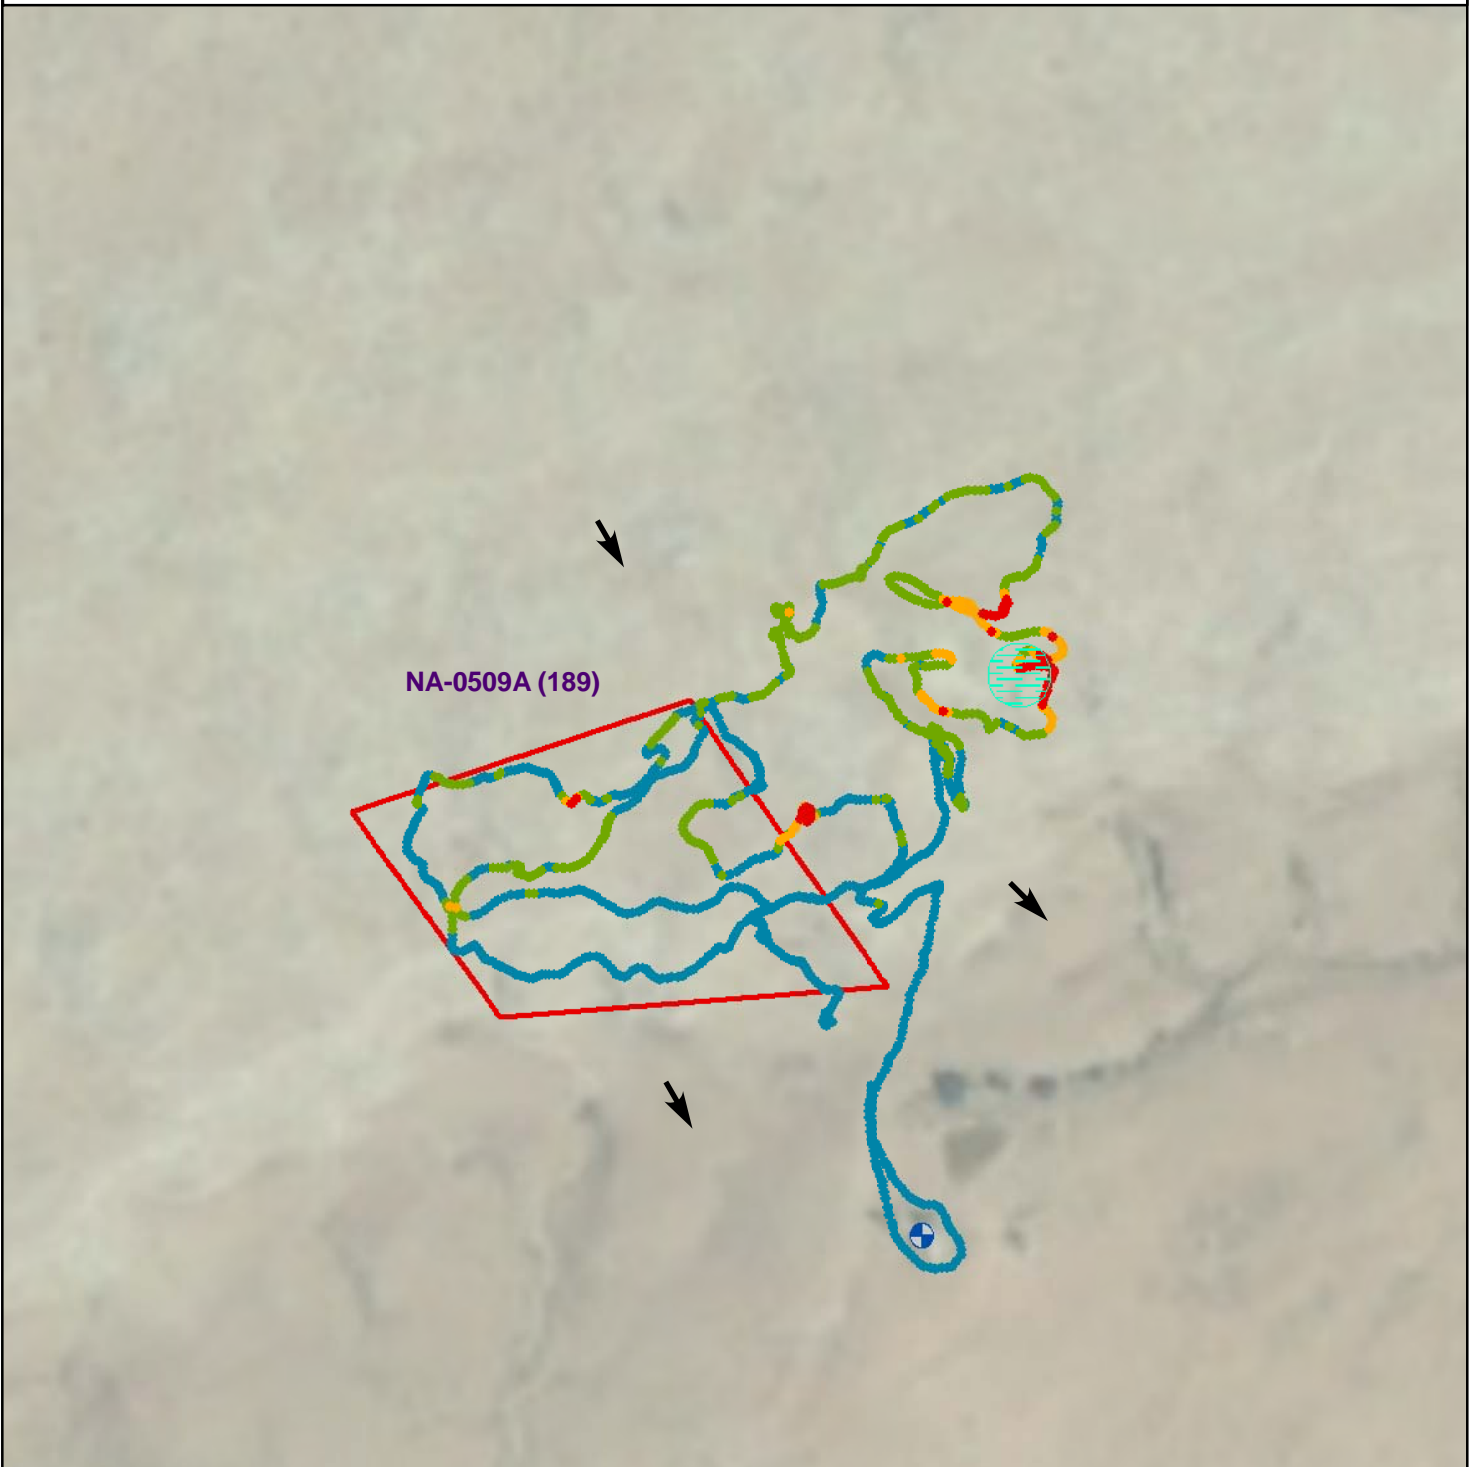
**Figure 2 - Gamma Radiation Measurements**  
**NA-0509A (189)**  
**Red Mesa Chapter, Navajo Nation**

Gamma survey conducted 06/2010  
 Measured as counts per minute (cpm)

Average background 7,749 cpm
